3M ESPE

Making Better Impressions

Trouble

Guide

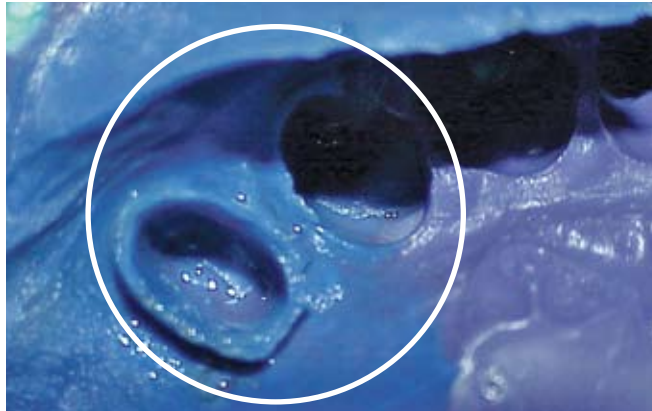
Visual Appearance: Impression not completely set. Shiny, no detail of site.

Sulfur inhibition due to contact of latex gloves with tissue/tooth/retraction material or impression material.

Residues from custom temporary or provisional cements (acrylics) present.

Inhibited Setting

Wear gloves proven not to contain traces of sulfur.

If contamination is suspected, scrub affected area with diluted hydrogen peroxide.

Do not use impressions already used to fabricate the temporary restoration.

Fabricate the temporary crown or bridge after final impression has been made.

Remove air-inhibited layer on the exposed surface with an alcohol wipe before making final impression.

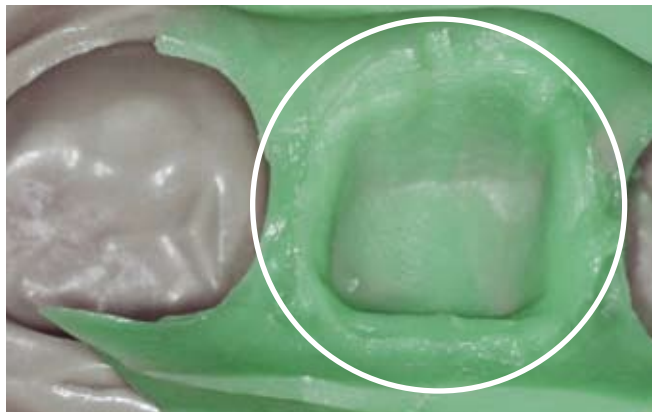
Visual Appearance: Muted detail reproduction.

Result: Crowns may be too tight, or loose, and not fit correctly.

Lack of Impression Detail

Substances with $\text{pH} < 4$ inhibit setting reaction, most commonly by contact with acidic retraction materials and hemostatic agents containing epinephrine or ferric sulfates.

Incorrect storage conditions of the final impression affects surface quality (detail reproduction) and dimensional stability.

Use retraction materials having $\text{pH} \geq 4$.

Select retraction materials and hemostatic agents not containing these chemicals.

Rinse, remove, and dilute hemostatic solution from the preparation with water spray and suction. Dry before taking the impression.

Rinse polyether impressions with water and blow dry before sending it to the lab.

Do not send the impression in the same bag as an alginate impression to the lab.

Avoid storing impressions in sealed bags.

Store the impression at room temperature away from direct sunlight.

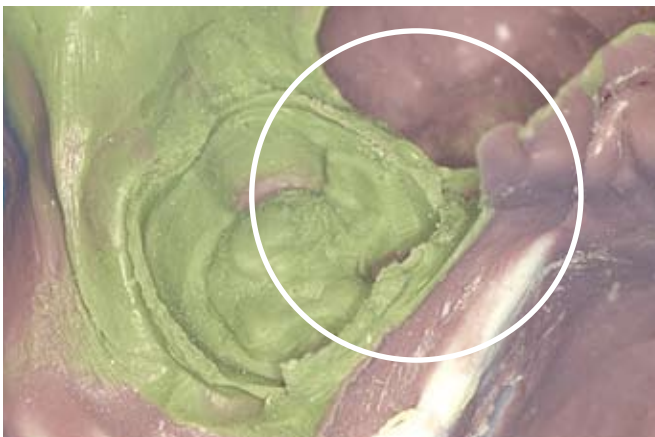
Poor Retraction and Syringing Technique

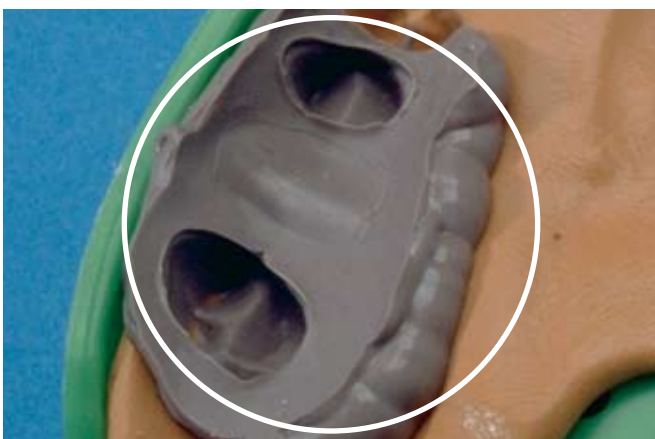
Exceeding the Working Time

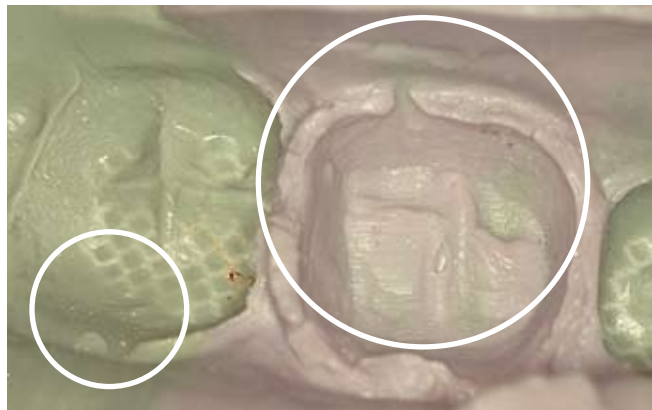
Visual Appearance: Voids/holes on margin of the prepared teeth. Incomplete margin.

Result: The fit and function of the final restoration may be compromised. Short crown margins and/or open margins.

Void Caused by Syringe Technique

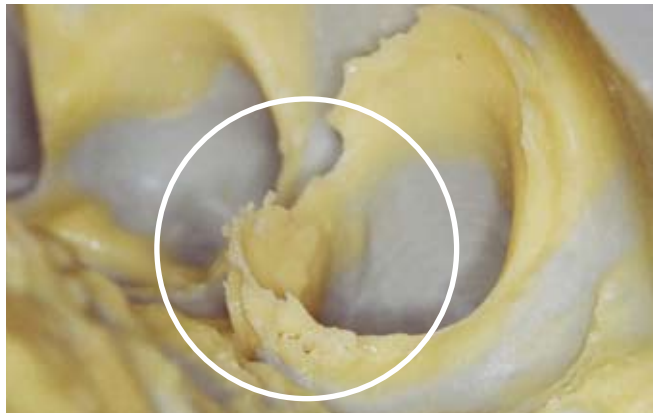
Visual Appearance: Rip, or visible tearing on the margin of the preparation.

Result: Short crown margins and/or open margins.

Poor Retraction — Insufficient Tear Resistance

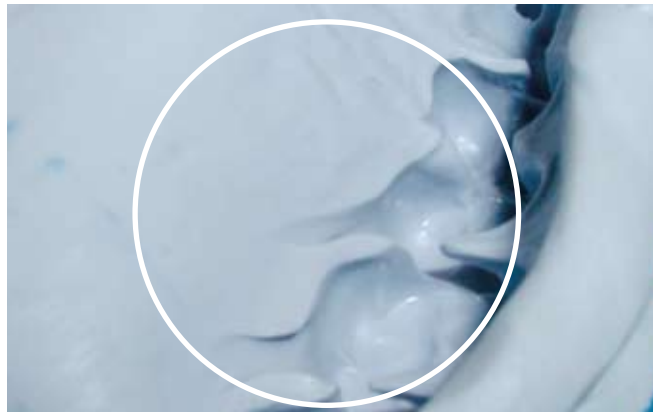
Visual Appearance: V-shaped void, trough-like.

Result: Failure to capture complete and accurate dentition.

CAUSE	SOLUTION
Exceeding the working time.	Follow manufacturer's working time specifications. Choose material with longer working time.
Tray movement or repositioning after seating.	Do not move tray after seating.
Insufficient amount of impression material used.	Use more material to create back flow effect.
Impression tray does not support flow of impression material.	Use lingual stops. Use an impression tray that supports the flow of the material.

Lingual Pulls

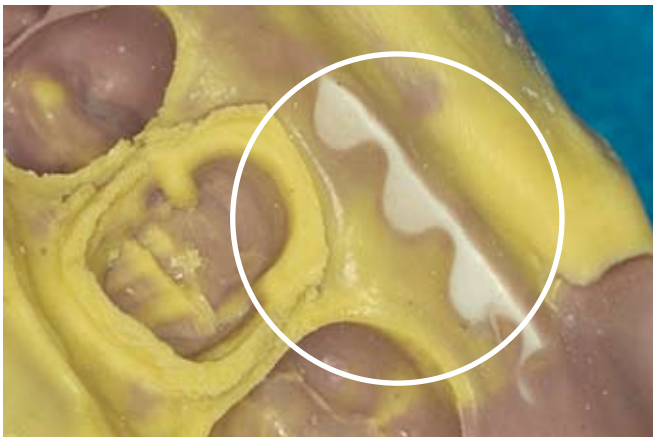
Visual Appearance: Show-through of tray. Impression tray exposed.

Result: Restoration may have slight distortion at marginal area, or rocks.

CAUSE	SOLUTION
Prepared teeth contact the sides or bottom of impression tray.	Use proper size tray. Test various tray sizes to ensure proper size.
Tooth contact with the pre-set tray material when using the two-step technique.	Carve out tray material properly before applying wash.
Insufficient impression material used.	Fill tray adequately.

Contact with Impression Tray

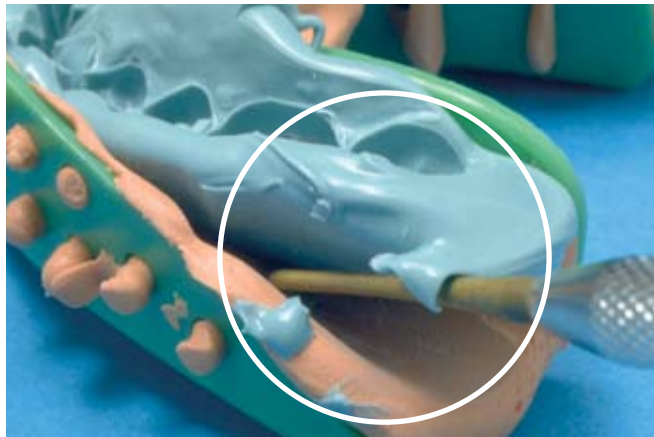
Visual Appearance: Heavy body and light body materials not blended, or mixed together.

Result: Restoration will not seat or fit properly.

CAUSE	SOLUTION
Exceeding the working time.	Follow manufacturer's working time specifications. Choose material with longer working time.
Impression material stored at elevated temperature.	Store impression material at room temperature.

VPS	SOLUTION
Sulfur or acrylic contamination of pre-set heavy body material in two-step technique.	Avoid contact with sulfur contaminants: Wear gloves proven not to contain traces of sulfur. Avoid contact with acrylic and methacrylic contaminants: Ensure impression material does not come into contact with methacrylate residue from acrylate temporary materials.

Poor Bond Between Heavy Body and Light Body Material

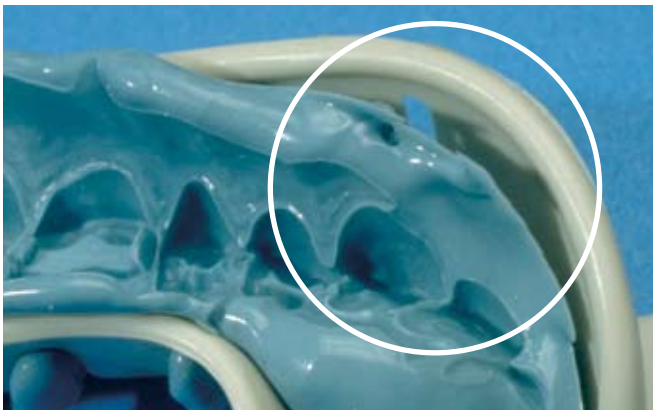
Visual Appearance: Impression pulling away from the sides/bottom of tray.

Result: Crown(s) may be tight and not seat fully, or require excessive internal adjustment.

CAUSE	SOLUTION
No tray adhesive used.	Use tray adhesive.
Incompatible tray adhesive used.	Use appropriate tray adhesive. VPS adhesive for VPS. Polyether adhesive for polyether materials.
Inadequate drying time for tray adhesive.	Follow manufacturer's instructions for application, and drying time.
Thin plastic trays allow deflection, which can cause rebound upon removal.	Use a tray that fits better, and is stiffer and more rigid.

Separation of Material from Tray

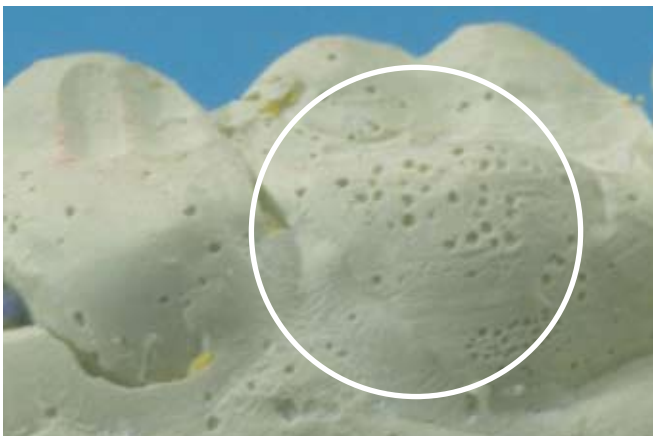
Hydrogen gas emission.

Stone Model with Hydrogen Evolution Voids

Follow manufacturer’s instruction for casting time.

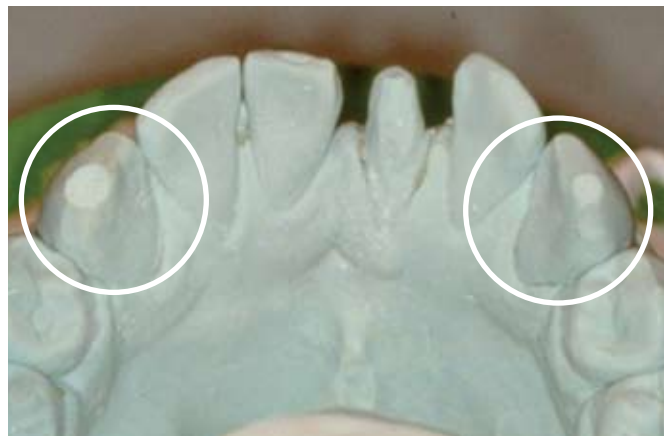
Visual Appearance: Voids on margin, powdery cusp tips on incisal edges on prepared tooth. “Golf-ball” appearance of stone model.

Tooth contact with impression tray, or gauze of double bite tray causes water to leach out of the tray, dehydrating the stone.

Stone Model with Powdery Cusp Tips

Instruct patient to bite passively in centric occlusion when using dual arch trays.

Fill tray with sufficient amount of material.
