3M ESPE

Making Better Impressions

Trouble

Guide

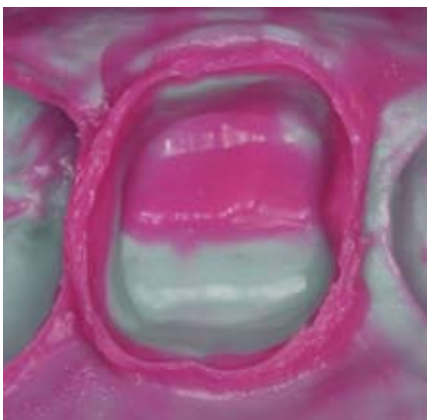
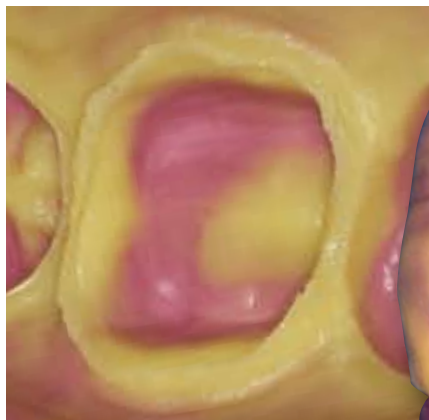
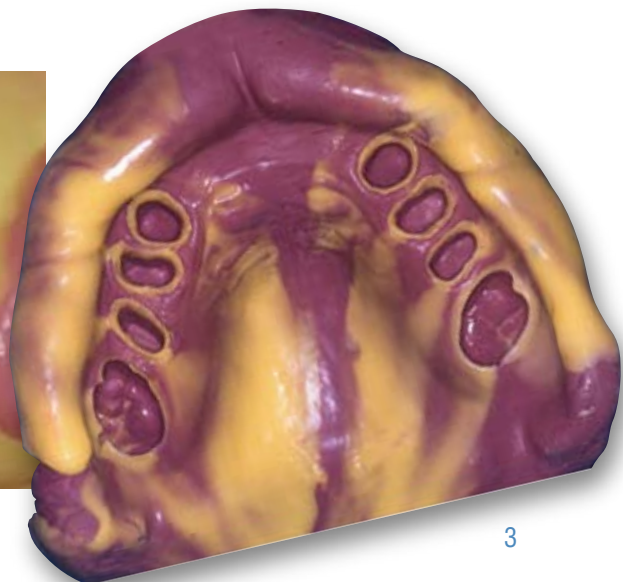
Inhibited or Slow Setting

Visual Appearance: Impression not completely set. Shiny, no detail of site.

Result: Inadequate surface detail on stone cast, poor fitting restorations.

Sulfur inhibition due to contact of latex gloves with tissue/tooth/retraction material or impression material.

Residues from custom temporary or provisional cements (acrylics) present.

Wear gloves proven not to contain traces of sulfur.

If contamination is suspected, scrub affected area with diluted hydrogen peroxide.

Do not use impressions already used to fabricate the temporary restoration.
